# Evaluation Report

# 476

## Massey Ferguson 885 Self-Propelled Windrower

## MASSEY FERGUSON 885 SELF-PROPELLED WINDROWER

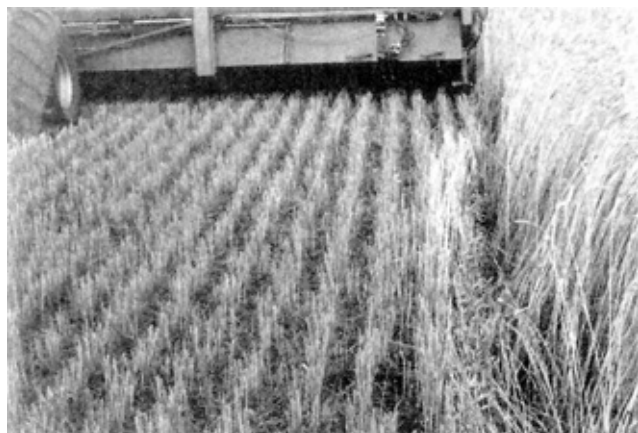
FIGURE 2. Crop Flattened by the Optional Gauge Wheel.

**Dividers:** Divider performance was very good. The smooth, narrow divider cleanly separated the crop, without hairpinning. However, the optional header gauge wheels trampled some crop behind the divider causing a slight crop loss (FIGURE 2). The gauge wheels and divider rod were adjusted, but crop loss still occurred. It is recommended that the manufacturer consider modifications to reduce crop loss caused by the optional gauge wheels.

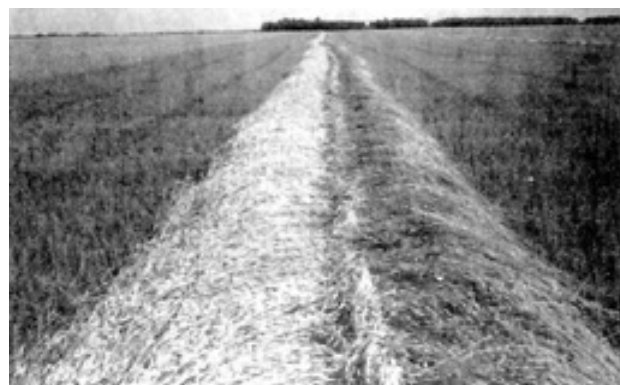
FIGURE 7. Wheat, Double Windrow: 45 bu/ac (3.0 t/ha).

windrow with less material on the right side, formed by the right divider draper (FIGURE 7).

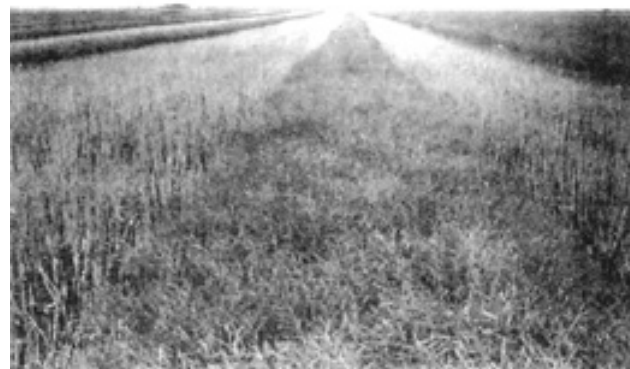
FIGURE 8. Rapeseed, Single Windrow: 41 bu/ac (2.2 t/ha).

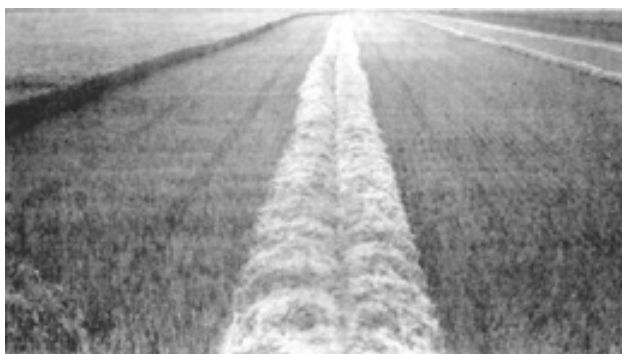
FIGURE 9. Barley, Double Windrow: 70 bu/ac (3.8 t/ha).

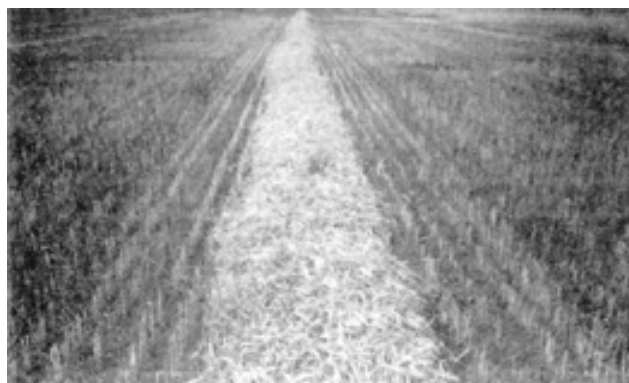
FIGURE 10. Fall Rye, Single Windrow: 22 bu/ac (1.4 t/ha).

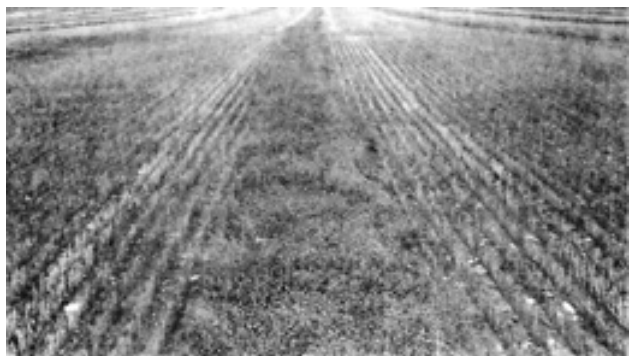
FIGURE 11. Flax, Single Windrow: 20 bu/ac (1.3 t/ha).
